**TEST REPORT NO. 6044-S3-NZ-2014**

# ZENDOW UPVC INWARD TILT-TURN WINDOW PROTOTYPE TEST to NZS 4211-2008

**DECEUNINCK**

**March 2019**

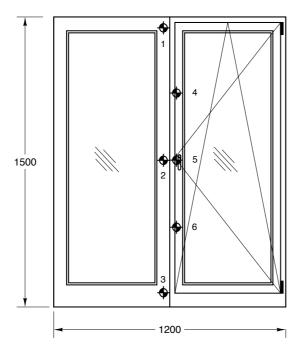
Figure 1. Indoor view of the test sample showing the displacement measurement locations.

# **INDOOR VIEW**

Displacement measurement locations:

- Mullion top
   Mullion centre
   Mullion bottom
   Door Stile top at lock
   Door Stile centre
   Door Stile bottom at lock

All test readings and calculated deflections are given in Table 1 and measurement locations are indicated on Figure 1.

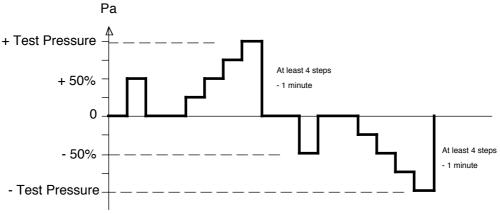
**Test pressure steps:** as given below
