**TEST REPORT NO. 6026-S3-NZ-2014**

**ZENDOW UPVC AWNING WITH FIXED  
LOWLIGHT WINDOW  
PROTOTYPE TEST to NZS 4211-2008**

**DECEUNINCK**

**March 2019**

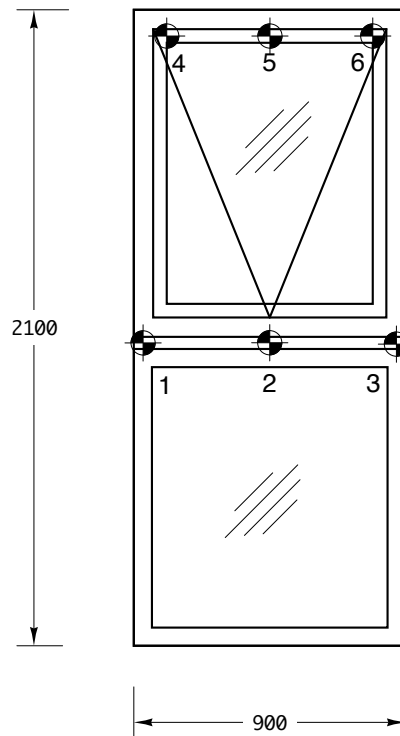
Figure 1. Indoor view of the test sample showing the displacement measurement locations.

**INDOOR VIEW**

Displacement measurement locations:

- |                     |                           |

| 1. Transom - left | 1. Sash top rail - left |
| 2. Transom - centre | 2. Sash top rail - centre |
| 3. Transom - right | 3. Sash top rail - right |

All test readings and calculated deflections are given in Table 1 and measurement locations are indicated on Figure 1.

DATAFILE 529		TEST NUMBER 1			DATE : 12/04/2006		
MEMBER	PRESSURE  (kPa)	DISPLACEMENTS ( rounded to 0.1 mm )			BENDING DEFLECTION ( rounded to 0.01 mm )  DC - $\frac{D1+D2}{2}$ DEF (mm)	SPAN  L (mm)	SDR  L/DEF
		LEFT OR TOP  D1 (mm)	CENTRE  DC (mm)	RIGHT OR BOTTOM  D2 (mm)			
1,2,3	TRANSOM

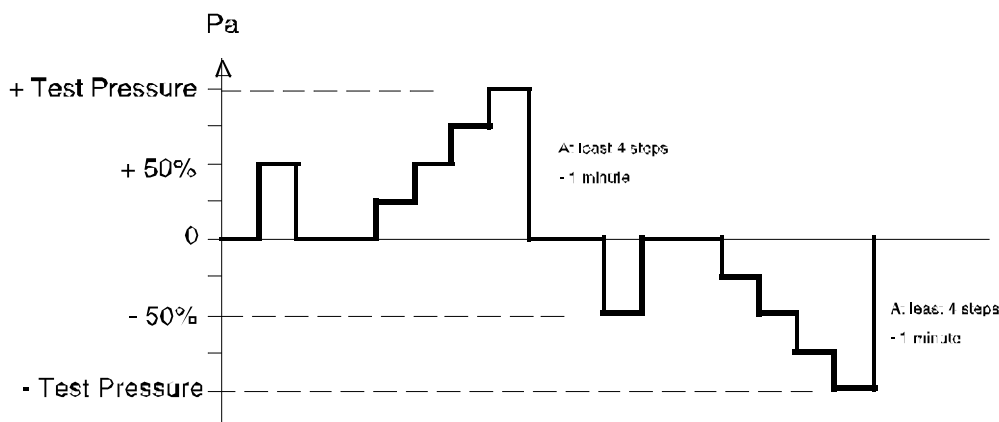
**Test pressure steps:** as given below

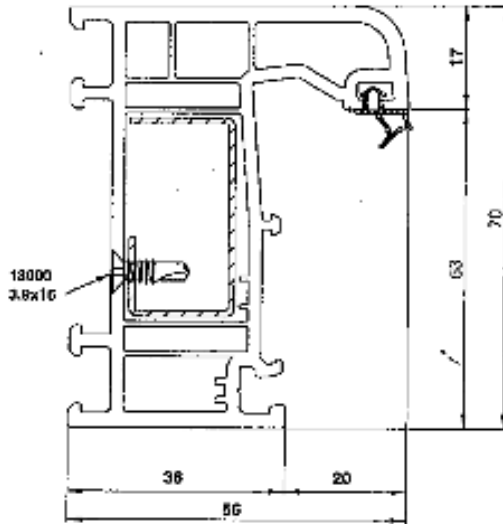
**12990**  
Ix : 1,3215 cm<sup>4</sup>  
Iy : 0,4993 cm<sup>4</sup>

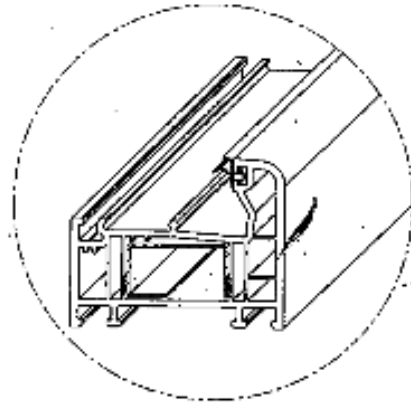
**12991**  
Ix : 1,2132 cm<sup>4</sup>  
Iy : 0,3124 cm<sup>4</sup>

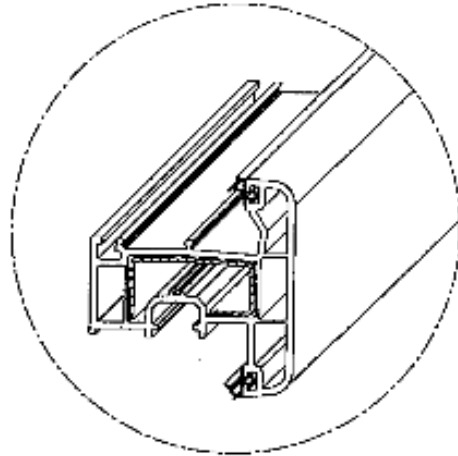
**13078**  
Ix : 2.4185 cm<sup>4</sup>  
Iy : 0.9497 cm<sup>4</sup>  
X  
Y

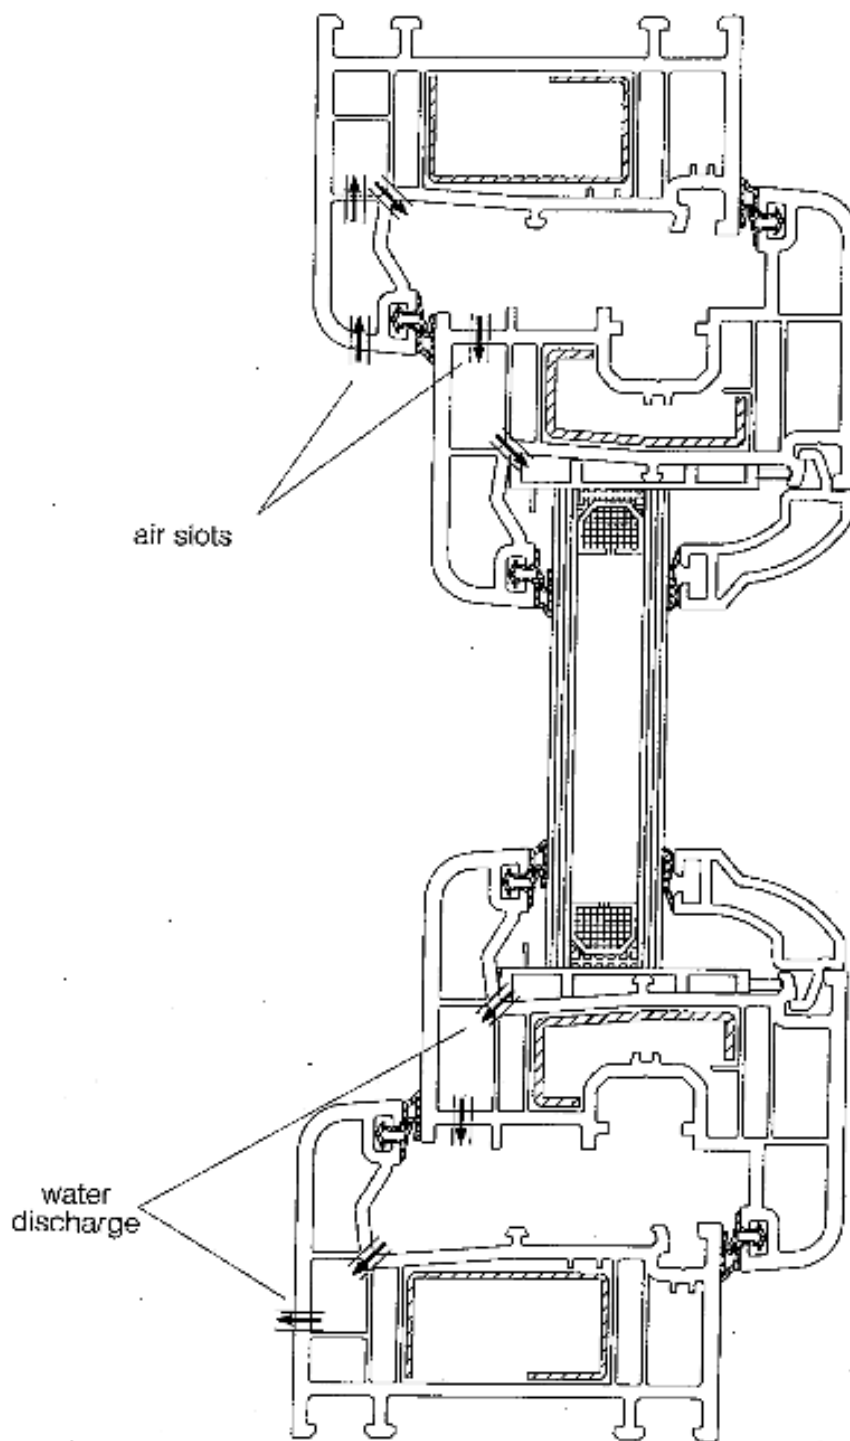
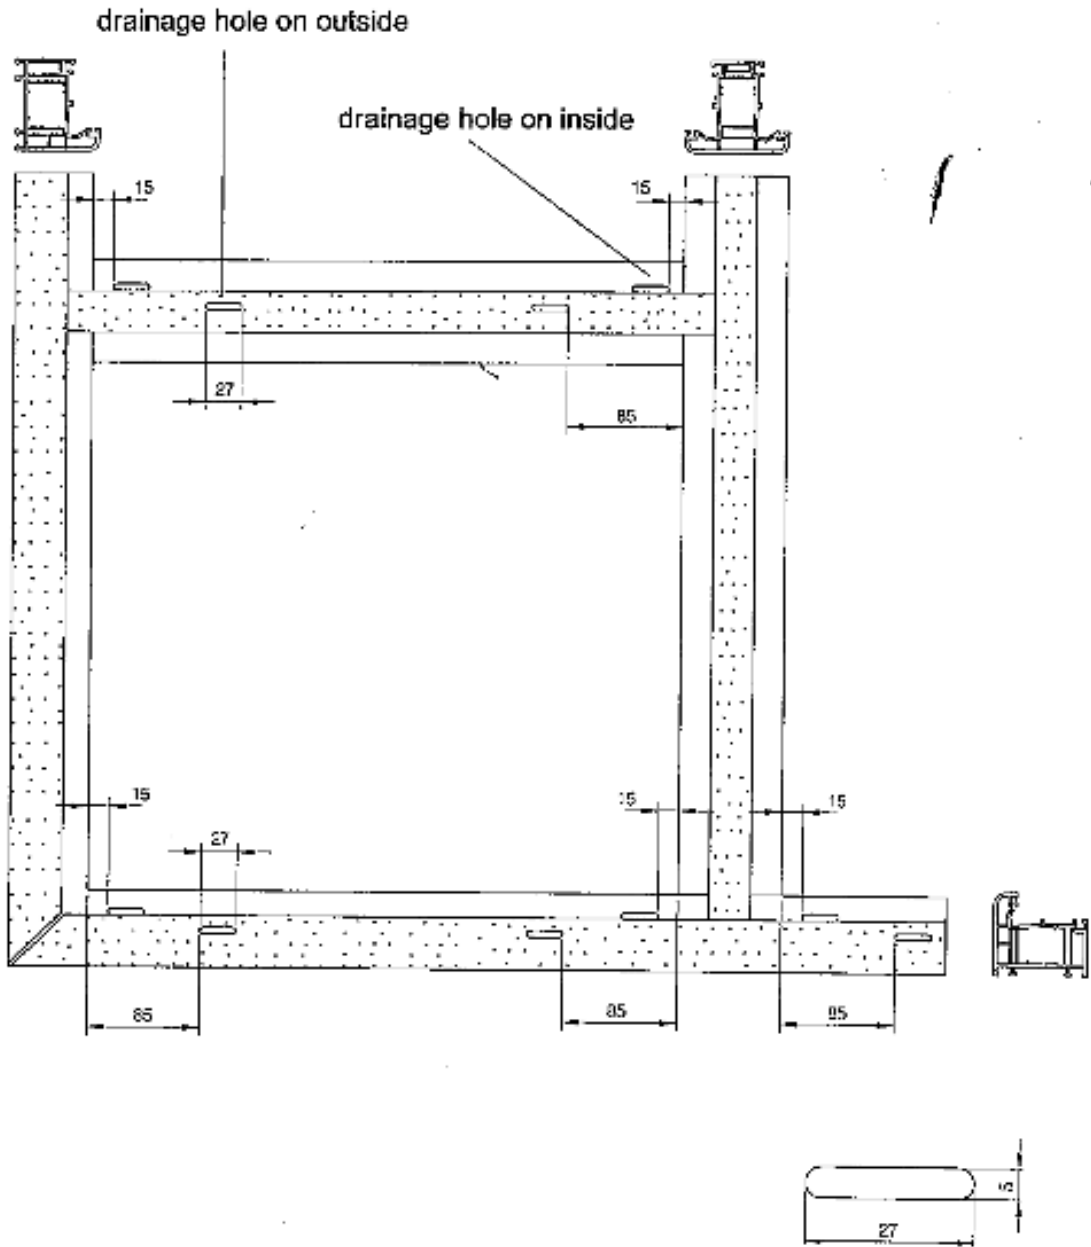
**drainage**  
**water discharge and air slots**

View from inside

## AWNING

Gaskets : TPE (Thermo Plastic Elastomer)  
Sealant used on outdoor gaskets.

Drain Holes – Frame : two on top panel  
two on bottom panel

Sash : two

A cap used outlet of each drain holes (part number 12084)

Air Slots – 5 mm diameter : two each pair of frame and sash

Glazing 4 mm Clear Float; 4-12-4 double glazing units used

The fasteners used to fix, each steel reinforcement should be no less than 3, with a gap around 300 mm.
